Minerals Inspection Report

Report Date: 04/21/2014 Mine Name: Pandora Mine Permit Number: M/037/0012 Mine Status: Active Operator Name: Energy Fuels Resources (USA) Inspection Date: 04/15/2014 Permit Fees: Paid Inspector(s): M. Bradley Inspection Time: 11:00a **Bond Amount:** \$175,811 Attendee(s): See below Weather: Pt. Cldy, cool **Bond Escalation:** 09/21/2015 Inspection Purpose: Routine inspection 06/13/2013 Prior Inspection:

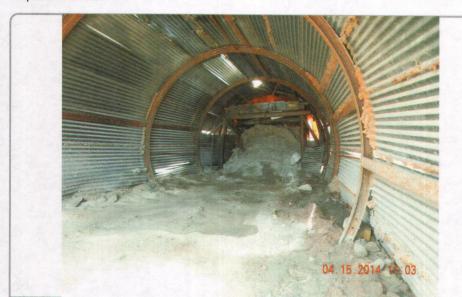
View into sealed portal

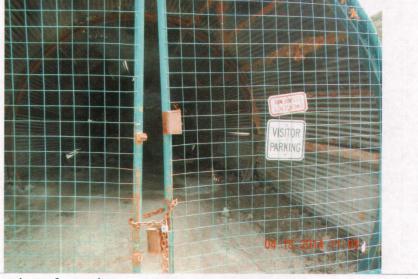
Security enclosure for portal

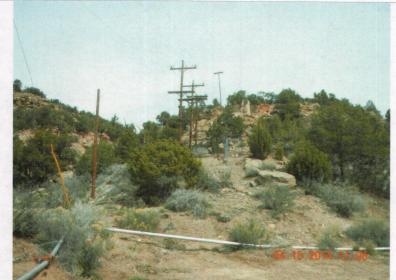
Utilities for site

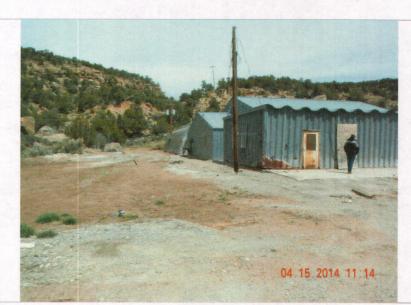
Facility buildings

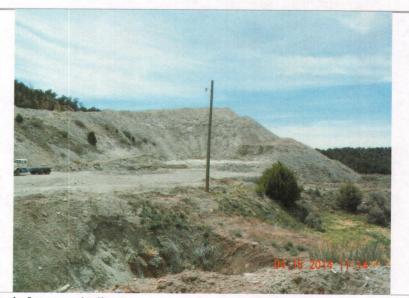
South end of waste rock pile
